ULTRASONIC EVALUATION OF DIFFERENT TYPES OF MORTARS SUBJECTED TO ATTACK BY PIG SLURRY

**CIGR INTERNATIONAL CONFERENCE OF AGRICULTURAL ENGINEERING
XXXVII CONGRESSO BRASILEIRO DE ENGENHARIA AGRÍCOLA – CONBEA 2008**

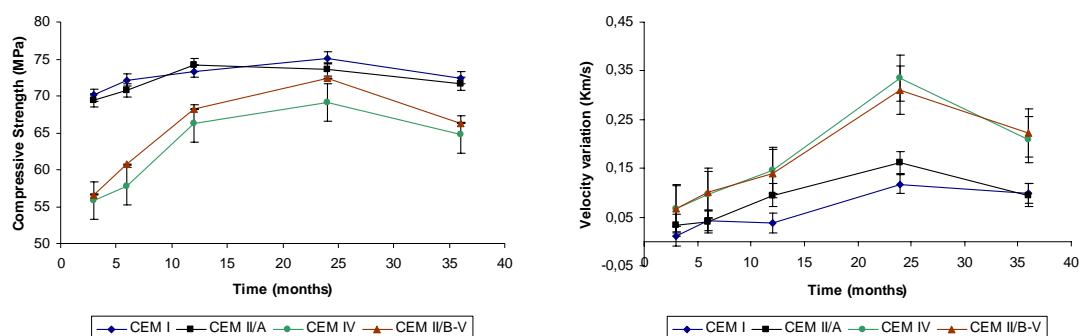
Figure 1a) shows the compressive strength evolution and variation of ultrasonic velocity evolution for the different cements during the period of the study.

FIGURE 1. a) Compressive strength evolution and b) Variation of ultrasonic velocity evolution in the different mortars.

In the first 24 months, the resistance increased in all the samples. The increase of compressive strength in mortar with fly ash can be due to increased hydration age. This behavior has also been observed by other authors (YONG-XIN LI et al. 2006; CYR, M. et al., 2006; SANCHEZ E. et al., 2008). After 24 months, the resistance of the mortars submerged in pig slurry decreased, which indicated the beginning of the degradation of materials. This behavior agrees with the report by de BELIE (1997).

The differences in ultrasonic velocity demonstrate a similar evolution over time, apart from CEM1, which shows insignificant differences between 3 and 6 months. Over the period of the test, the compressive strength and differences in ultrasonic velocity showed similar behaviours with respect to time, in line with QASRAWI H.Y. (2000) and del RIO, L.M. et al. (2004).

A good correlation ($0.7 < R^2 < 0.98$) exists between the variables considered and the polynomial functions of the time factor. The results of compression (f_c) and the variation of ultrasonic velocity values (Δv) are related by the ratio $\Delta v/f_c$ that also follows a type (1) polynomial law.
